US Army Corps
of Engineers®
Engineer Research and
Development Center

Opportune Landing Site Program

Opportune Landing Site Southeastern Indiana Field Data Collection and Assessment

November 2008

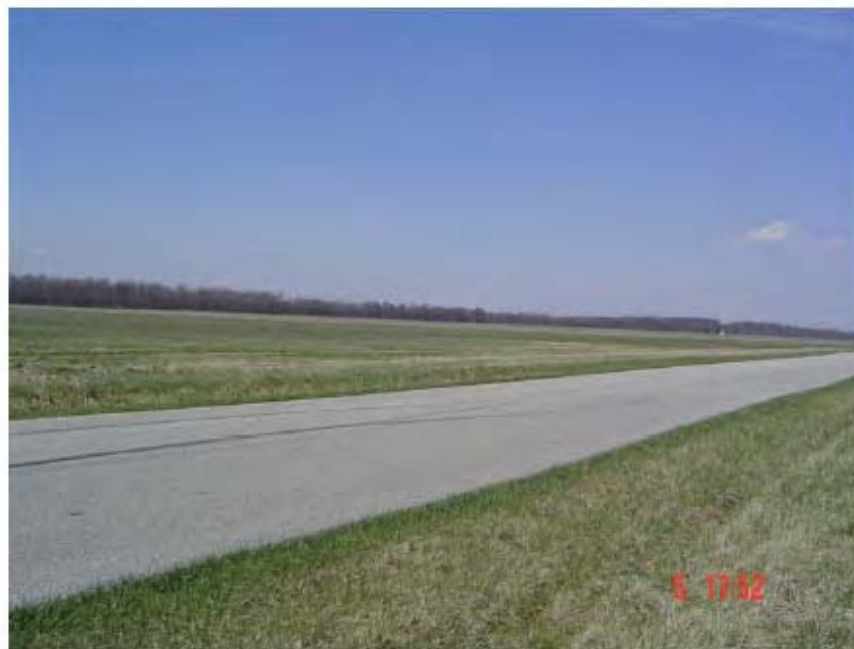
Figure 2-4. Field in Area 2 containing OLS cluster near North Vernon Municipal Airport as viewed from the road.

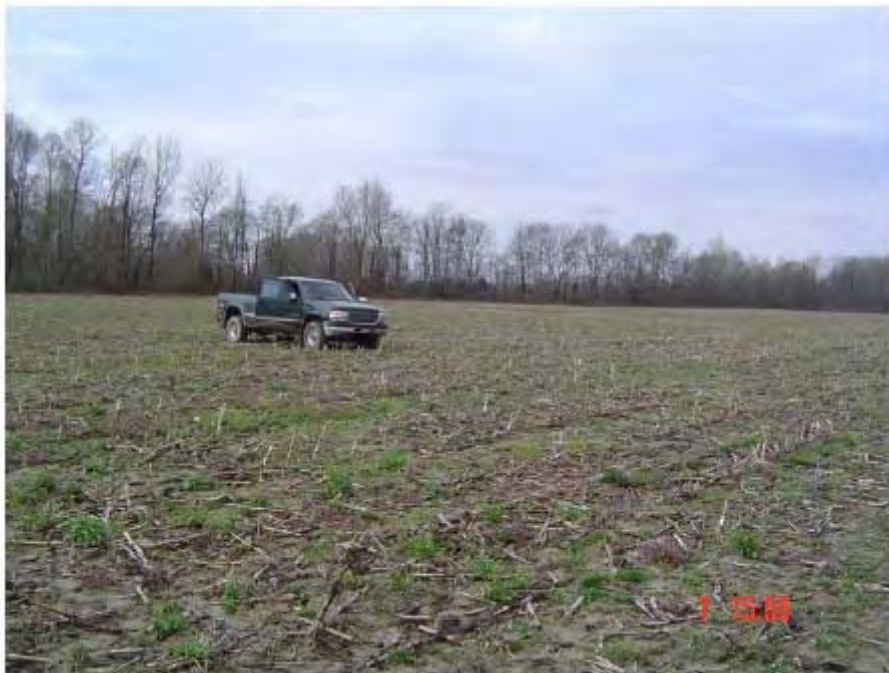
Figure 2-6. Near the end points of OLSs 1458 and 1459 located at the Ford Farm.

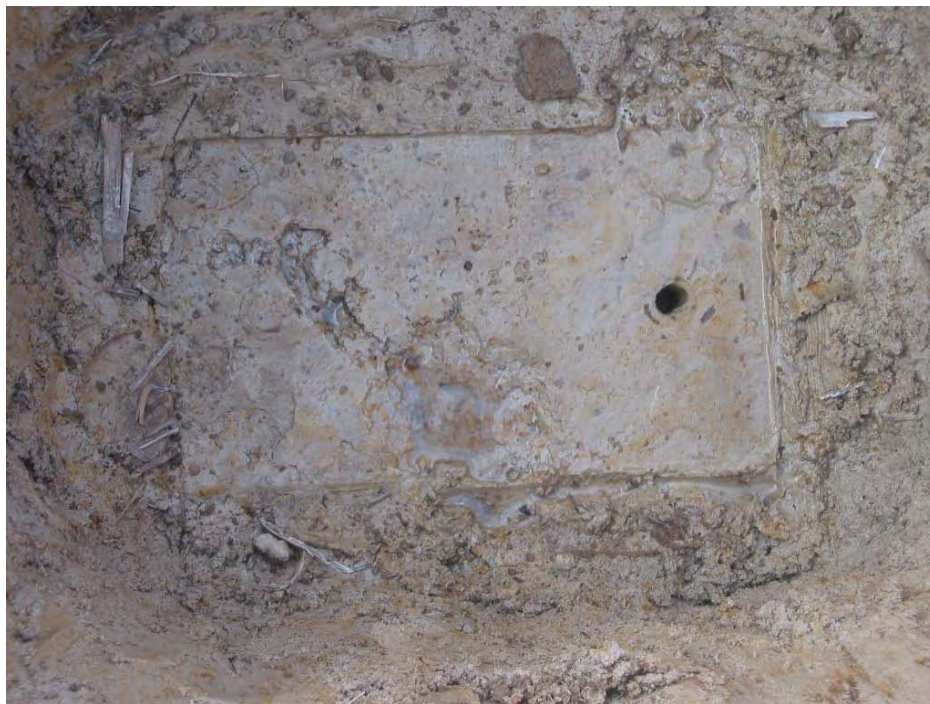
Figure 3-3. Water moving up to the bottom of the soil pit. The imprint is from the base of the Troxler nuclear gauge where moisture-density readings were taken.

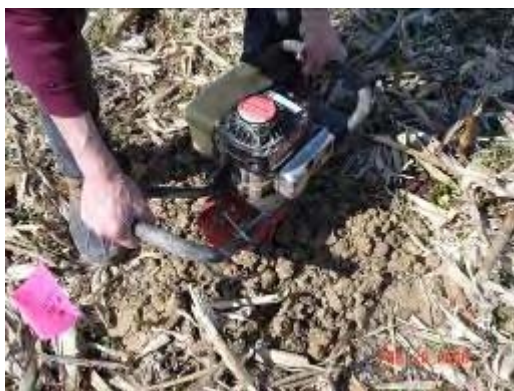
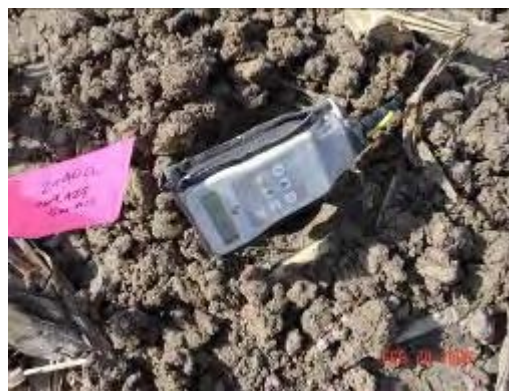
3-7a. Station 60 m Centerline.

3-7b. Station 240 m Centerline.

Figure 3-7. Using auger to drill a hole to collect subsurface soil moisture readings.

Volumetric moisture content readings were taken with depth using a Dynamax ThetaProbe ML2. Gravimetric soil moisture content measurements, expressed as a percentage of the dry weight of the soil, were obtained by oven drying soil samples, collected from the soil pits, in the laboratory. During IOPs when soil pits were not dug, a gas-powered auger was used to take moisture readings at depth (Fig. 3-7). This approach was not used more frequently because the soil cuttings came from a greater depth range (such as 305–610 mm [12–24 in.]).

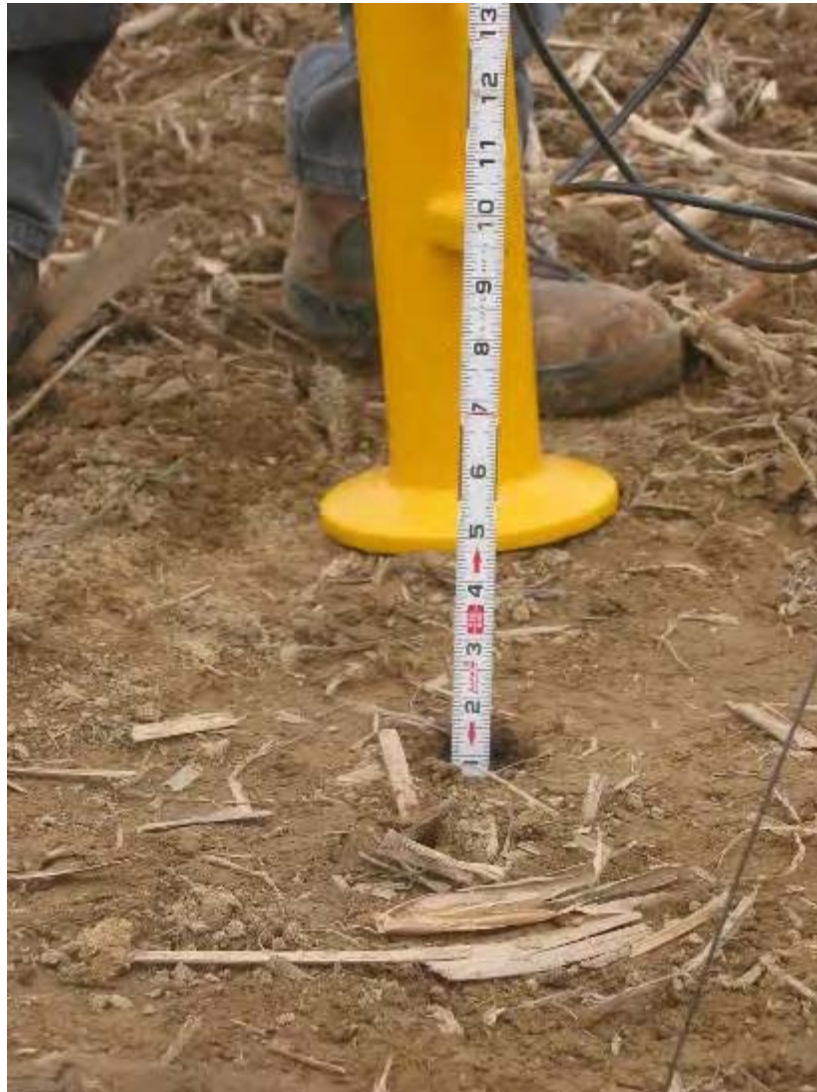
Figure 3-9. Typical indentation when attempting to use the standard (4.5-kg) Clegg hammer for upper soil strength measurements.

When it first became apparent that the standard Clegg hammer was unsuitable for taking soil strength measurements during the spring IOP1, a vehicle cone penetrometer served as an alternative tool. The cone penetrometer is a testing device used to expediently determine the trafficability of soils (HQ Army and Air Force, 1994). It consists of a steel rod 16 mm (5/8 in.) in diameter and 483mm (19 in.) long, tipped with a 30° cone having a 322-mm² (0.5 in²) base. This tip size is suitable for fine-grained soils. On the top of the rod is a proving ring with a micrometer dial ranging from 0 to 68 kg (0–150 lbs), although some dials range up to 137 kg (300 lbs). The dial reading is a cone index value indicating the soil's shear resistance. To operate the instrument, the rod is set vertically on the surface of the soil and with a steady downward force, the tip is pushed into the soil. Dial readings are recorded at designated intervals. The data are processed by calculating an average of the dial readings in 152-mm (6-in.) increments (from the top of the cone to 150 mm [6 in.], and then 150–300 mm [6-12 in.]). The CBR was estimated using the following exponential relationship based on data collected using a small-aperture CBR test and laboratory data collected at ERDC-CRREL (Shoop et al. 2008):

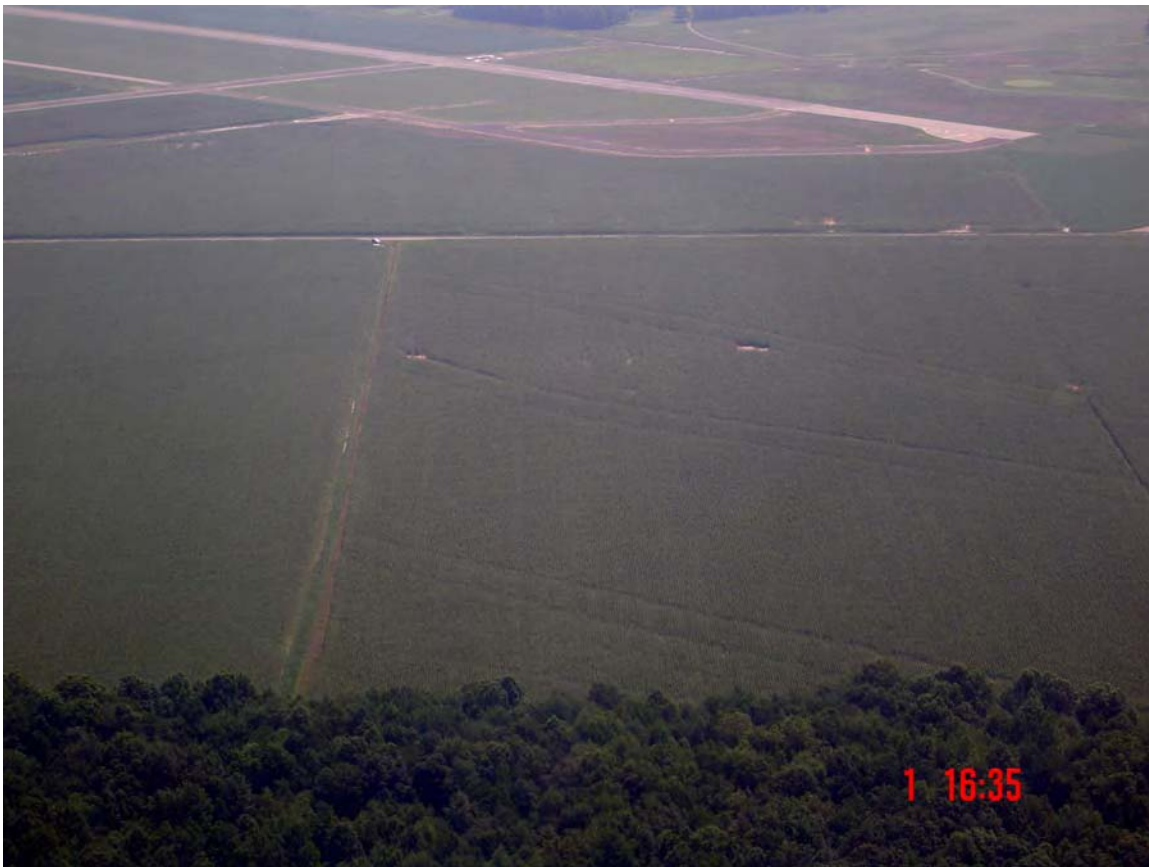
Figure 4-1. An aerial view of the North Vernon Airport RAS location taken during the summer 2005 field visit. The location of North Vernon Municipal Airport runway is indicated at the top of the photograph.

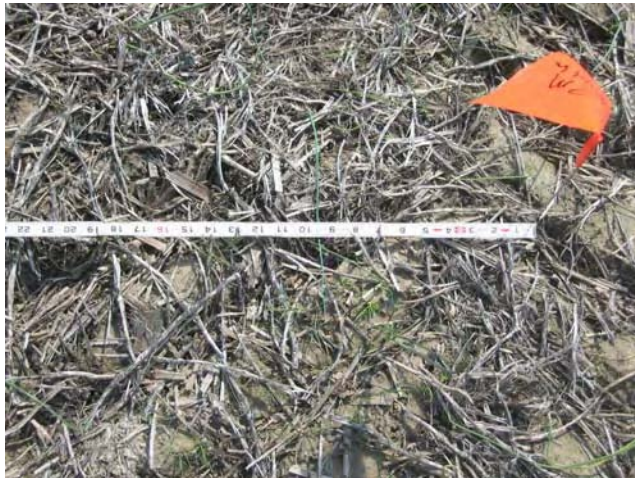
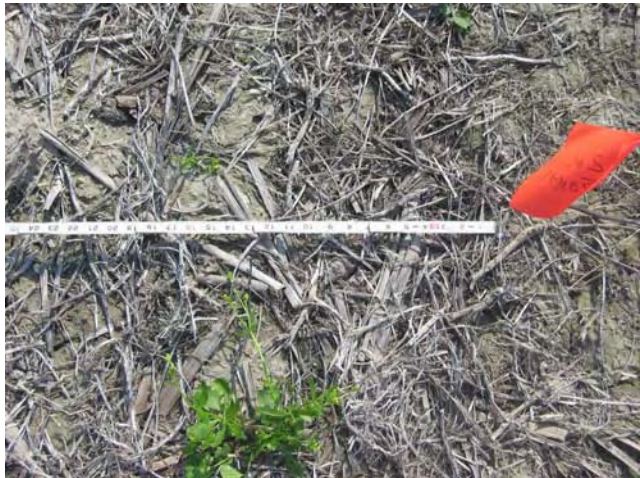
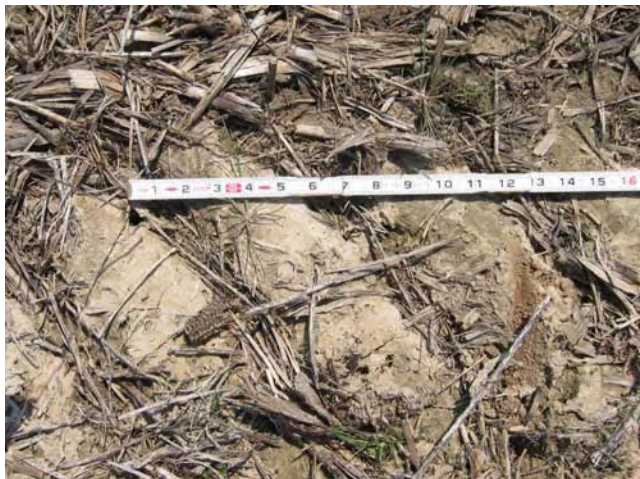
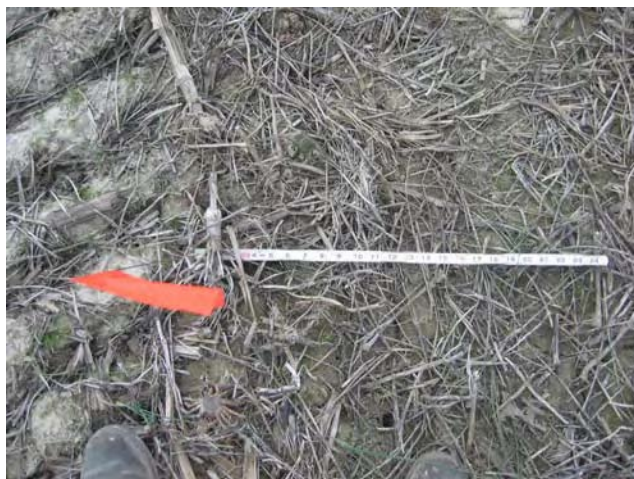
4-4a. 120 m 2 m North

4-4b. 180 m 2 m South

4-4d. 300 m Centerline

4-4e. 480 m 2 m South

Figure 4-4. In situ surface condition at North Vernon Airport RAS soil pit locations.

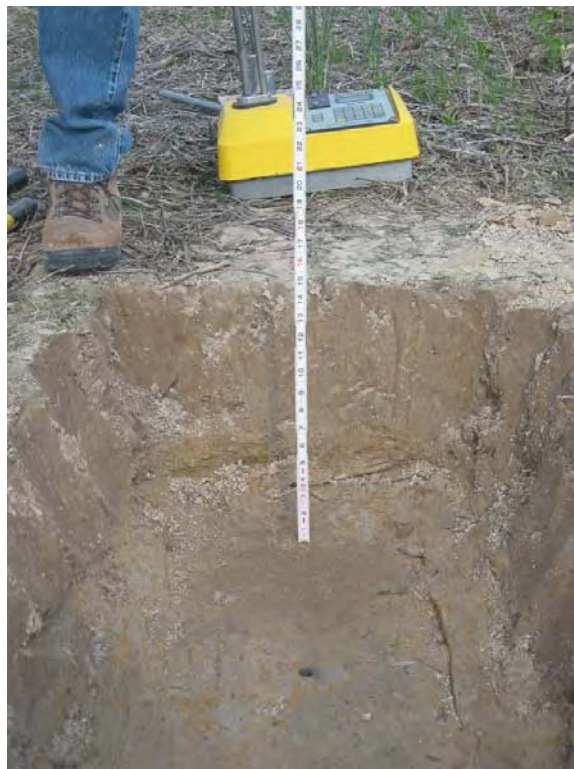
Figure 4-7. Station 480 m 2 m South, upper 300 mm of soil pit. Note the color change in the soil at the bottom of the pit.

The photographs in Figures 4-7 and 4-8 show examples of the material in the upper and lower layers of the soil pits. Figure 4-7 is from the upper 300 mm at the soil pit located at 480 m 2 m South and is representative of the upper layer along the RAS. There is a distinct change in the soil color,

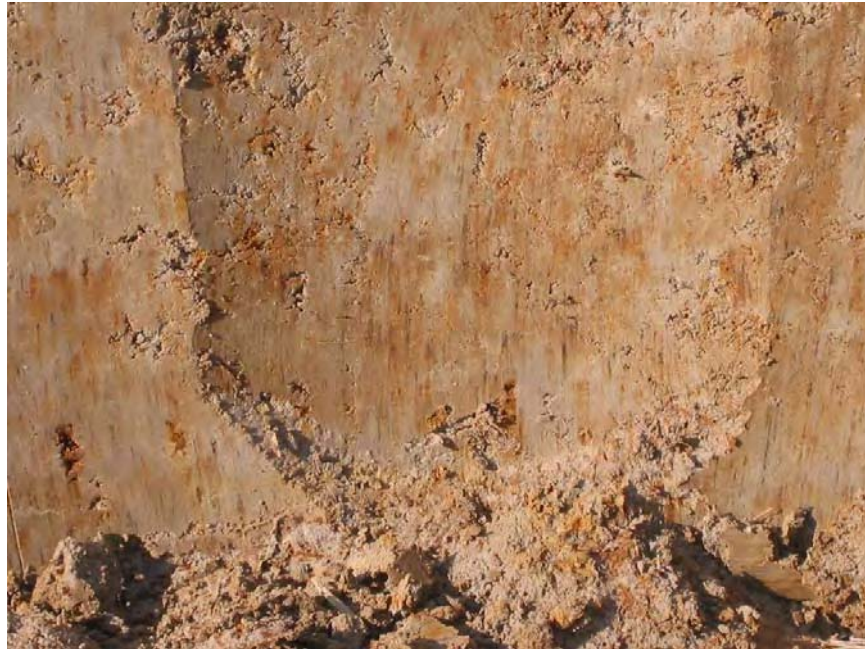
Figure 4-8. Close-up of mottled soil at bottom of pit, Station 300 m Centerline.

most likely from farming. Figure 4-8 shows a close-up of the soil pit at Station 300 m Centerline. The soil pictured in Figure 4-8 is representative of the bottom soil layer found at the soil pit locations in the RAS. As the soil pits were excavated, there were many large pore spaces encountered from worms, snakes, and crayfish, whose mounds (Fig. 4-9) were scattered over the surface of the North Vernon Airport RAS.

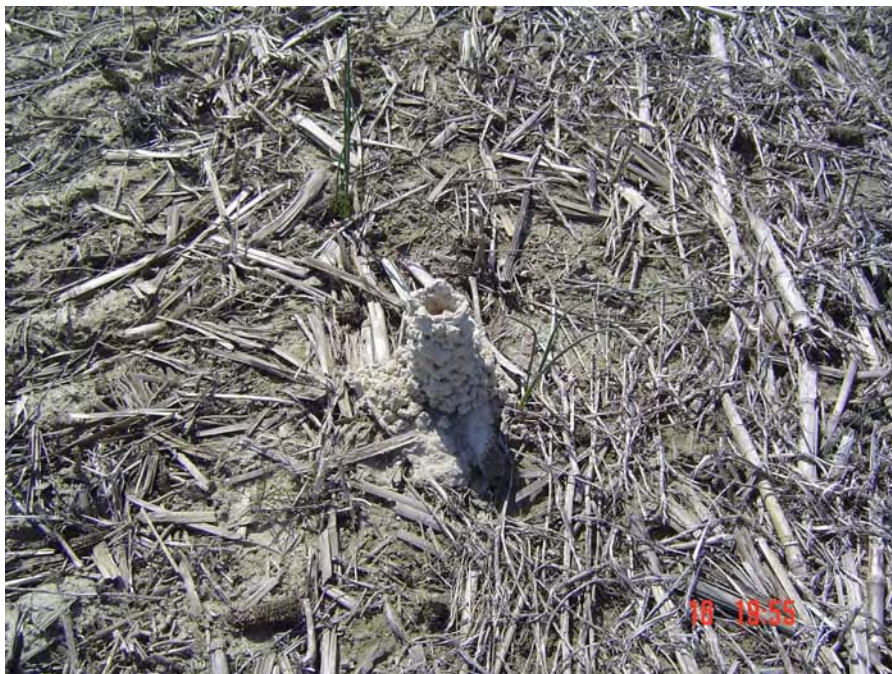
Figure 4-9. Crayfish mound on North Vernon Airport RAS.

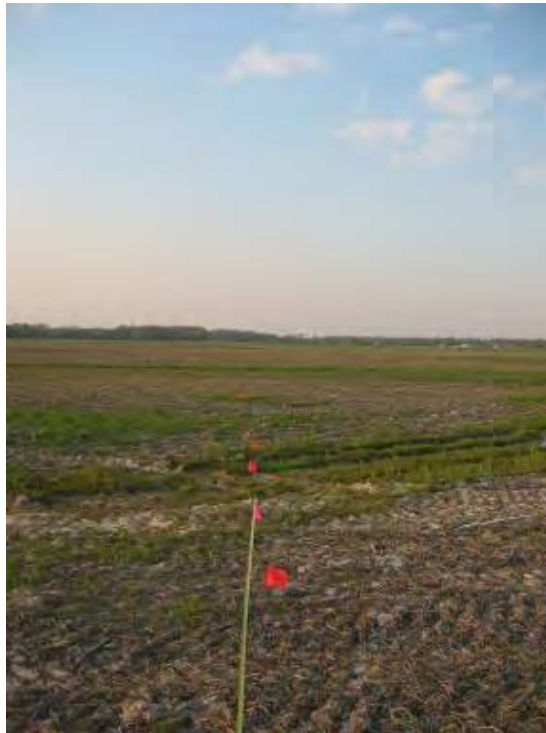
4-13 c. Station 240 m 2 m North distant view looking north across transect.

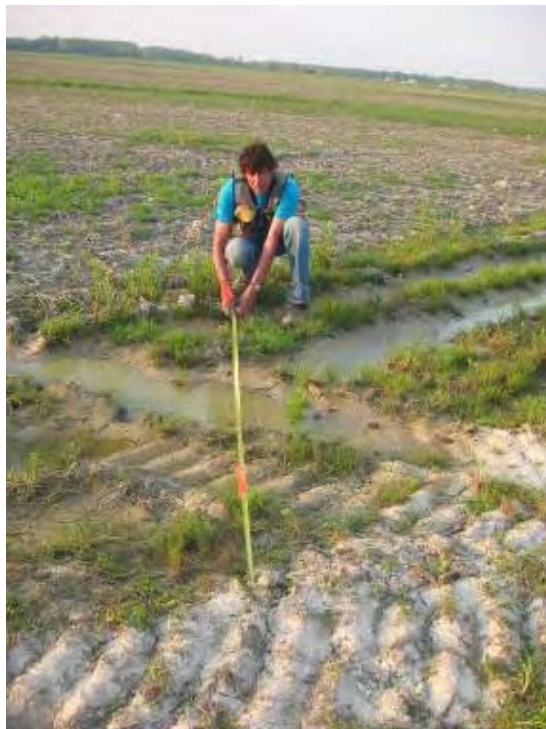
4-13 d. Station 240 m 2 m North, location of ponded water in proximity to soil pit location (lower survey flag).

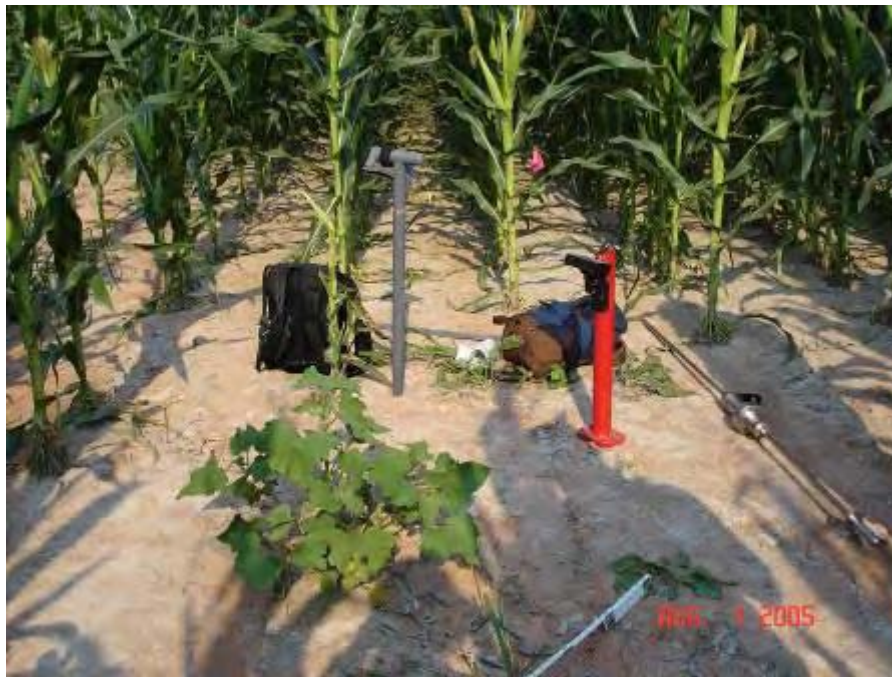
Figure 4-19. North Vernon Airport RAS during summer IOP2. The surface of the soil is dry and cracked. Note the density of the vegetation.

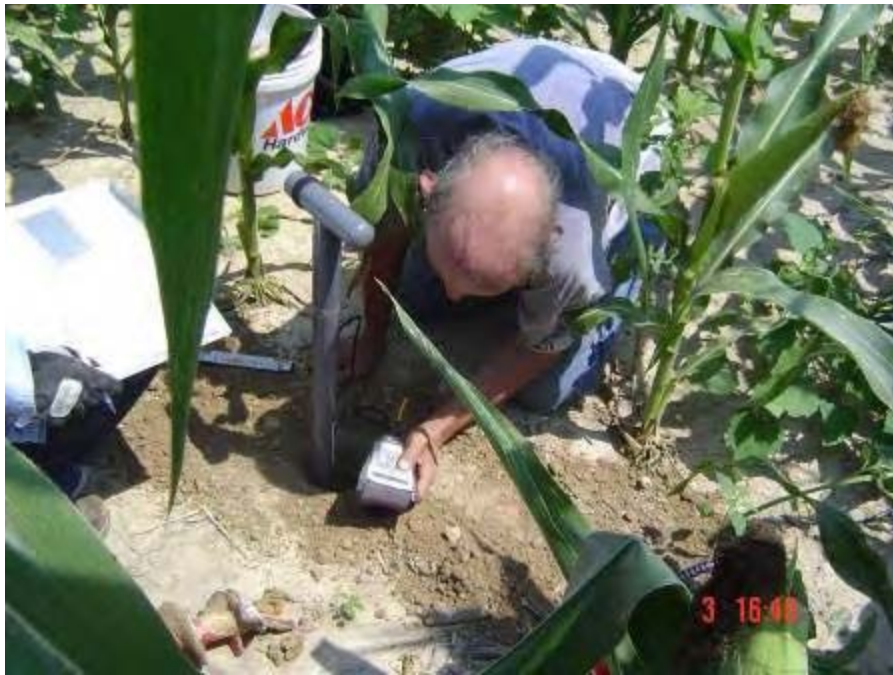
Figure 4-20. Taking soil moisture readings with a Dynamax ML2 in the auger hole (North Vernon Airport RAS, summer IOP2).

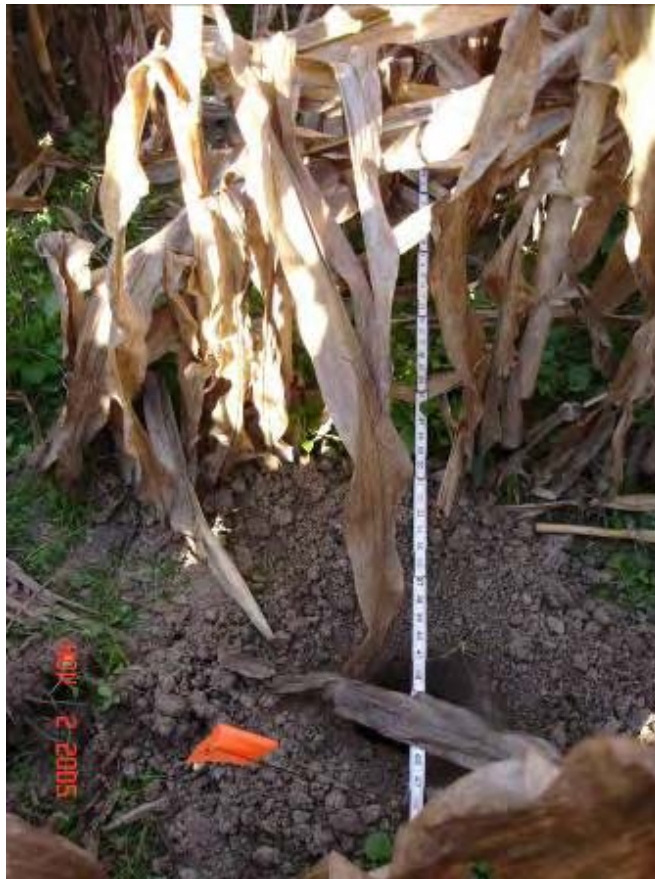
Figure 4-22. North Vernon Airport RAS fall IOP3 sampling station showing dried cornstalks, surface vegetation, and auger hole for soil moisture measurements (foreground).

The outstanding feature from the fall IOP was the dried corn stalks, roughly 6-ft tall, covering the field. This type of distress would likely be considered unsuitable for aircraft operations (Fig. 4-22). Close to the soil surface was low-growing vegetation (Fig. 4-23). The greater portion of any area on the RAS was covered with a combination of dried or low-growing vegetation, as shown in Figure 4-23. The only areas where bare soil was exposed were near the drainage ditches. The combination of low-growth vegetation and debris on the surface were a hindrance when taking surface strength measurements with the Clegg hammer. At the end of the fall IOP3, large harvesting equipment was used to cut the corn stalks and harvest the corn. Figure 4-24 shows the condition of the field after harvesting, with rows of stubble approximately 300–400 mm (12–16 in.) high (this field was across the street on the east end of the RAS); Figure 4-25 is a close-up photo of the surface, showing the large pieces of debris left after harvesting.

The median values are plotted in Figure 4-26. The median (32.6%) for the surface readings was high due to the rainfall received on the previous day. Still, the median moisture content of the surface was approximately 4% higher than the median values at both the 12- and 24-in. depths, which were the same at 28.7%. Because the median value at the 6-in. depth was very similar (28.5%), the median was not included on the plot. At the 30-in. depth, the median value was 32.4%. No clear trends are present in the data points; they appear to scatter around the median values at each depth. This shows that the moisture content was consistent throughout the soil layers with both the uppermost (surface) and the deepest 750-mm (30-in.) layers having higher moisture contents. The increased soil moisture was visible in the soil cuttings as the hole was drilled with the auger. As may be seen in the photograph of Figure 4-22, the cuttings clumped together.

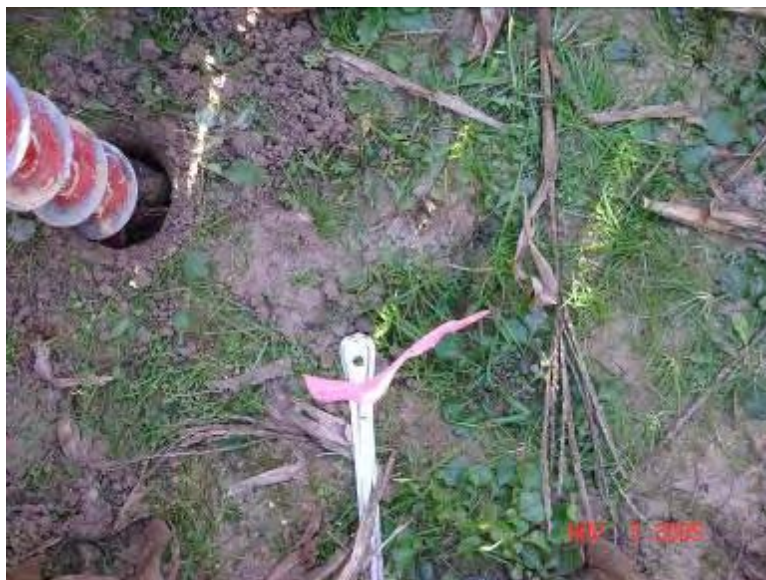
Figure 4-23. North Vernon Airport RAS fall IOP3 sampling station showing vegetation and auger hole for soil moisture measurements.

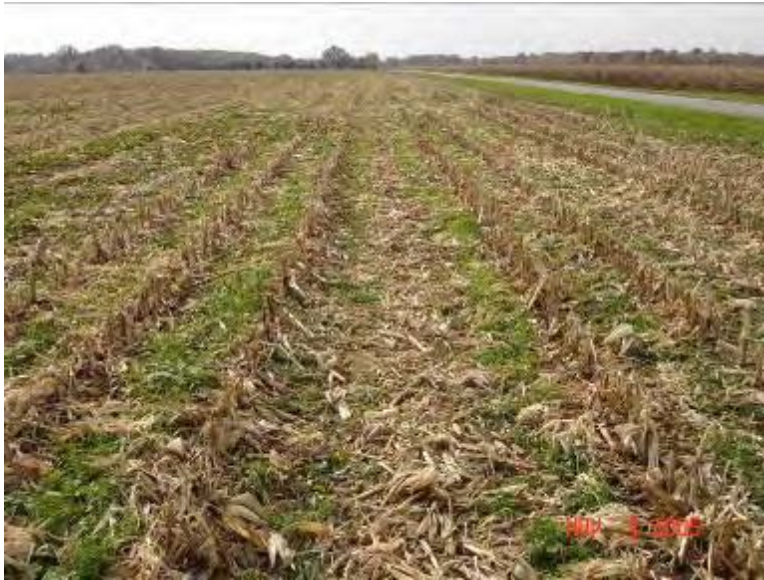
Figure 4-24. North Vernon Airport RAS rows of stubble after harvesting, fall IOP3.

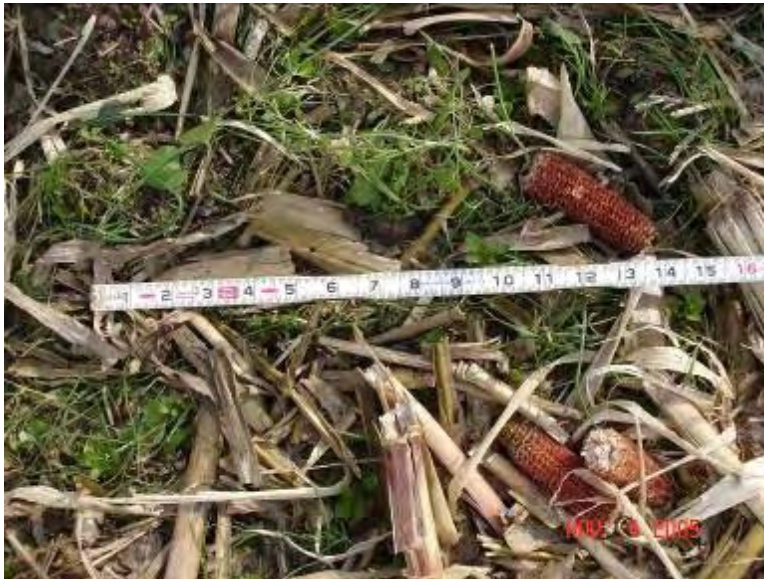
Figure 4-25. North Vernon Airport RAS close-up of surface, fall IOP3.

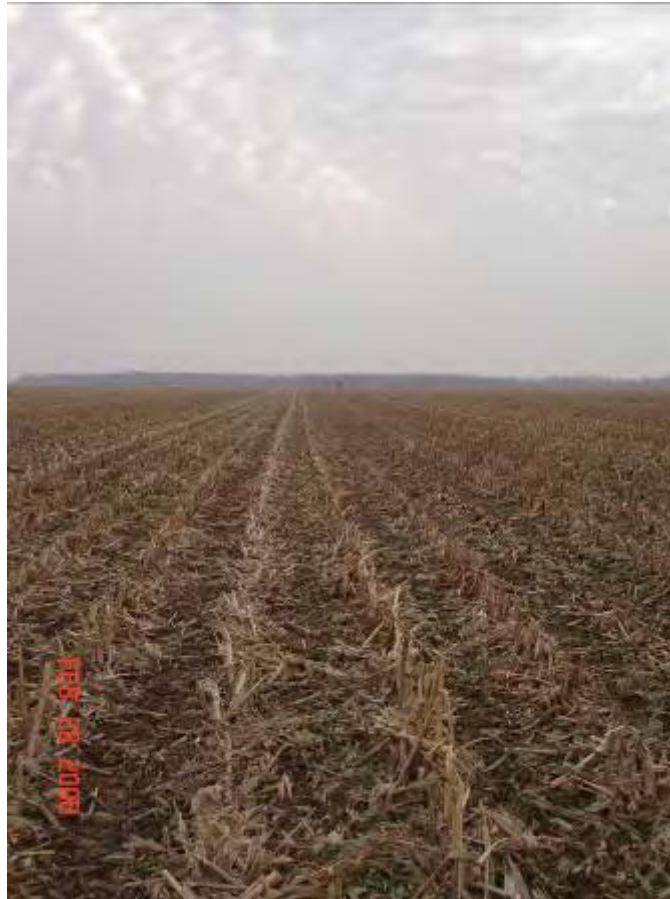
Figure 4-28. View looking down centerline from Station 600 m at North Vernon Airport RAS, winter IOP3.

The surface of the soil was wet. In some places where the moisture content was very high, it was slippery. Vehicle traffic on the surface was prone to getting stuck, more from lack of track rather than sinking into soft soil. Figures 4-28 and 4-29 show the general surface conditions during IOP4.

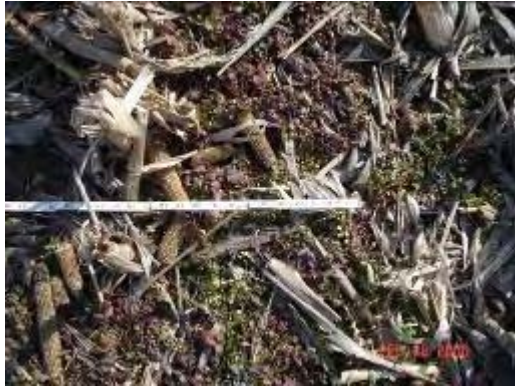
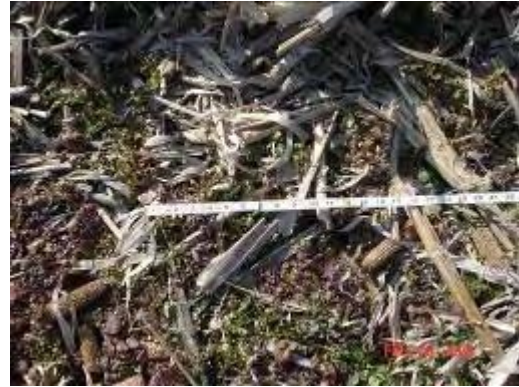
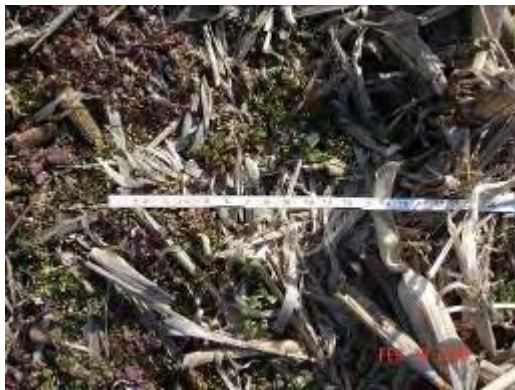
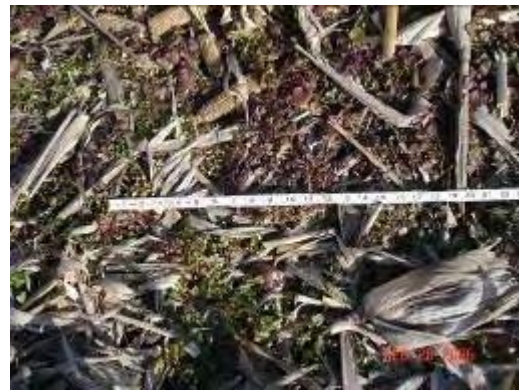
Figure 4-29. Surface coverage photographs around North Vernon Airport RAS, Station 300 m Centerline survey flag, during winter IOP4; (a) north, (b) west, (c) south, and (d) east.

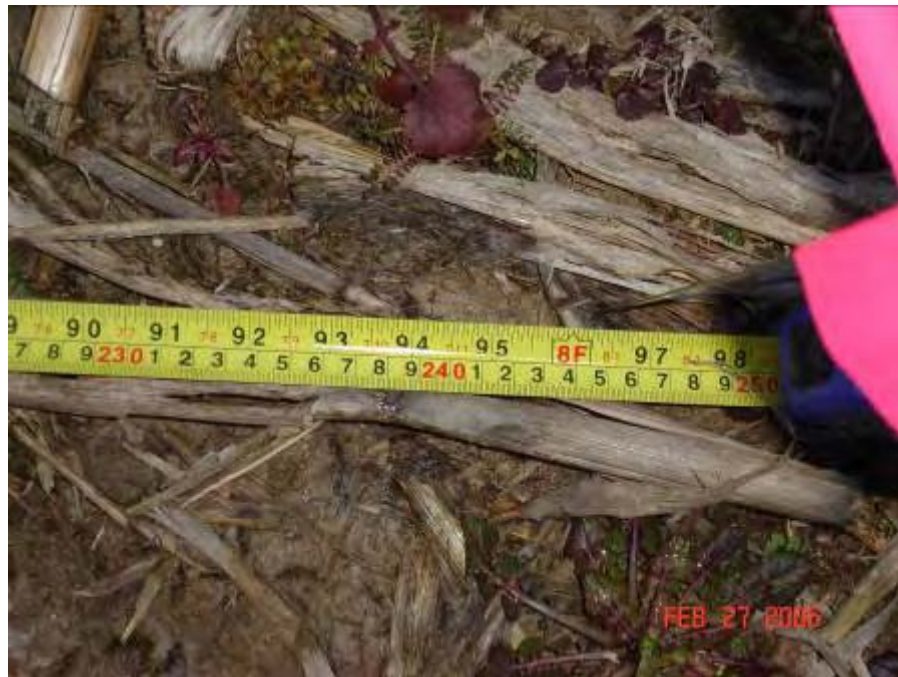
Figure 4-30. North Vernon Airport RAS surface moisture during the winter IOP4.

The photograph in Figure 4-30 shows an example of the moisture on the surface. Moisture content data and median values are given in Table B-11, Appendix B. The median values at depth are plotted in Figure 4-31. Note that the median moisture content for all of the layers, with the exception of 11–14 in. below the surface, are consistently near a 40% volumetric moisture content. At the 12-in. depth, the data points trend in a convex pattern, with the ends of the RAS being slightly drier than the center, where the highest moisture content was measured. The data points at the other depths tend to be scattered around the median value.

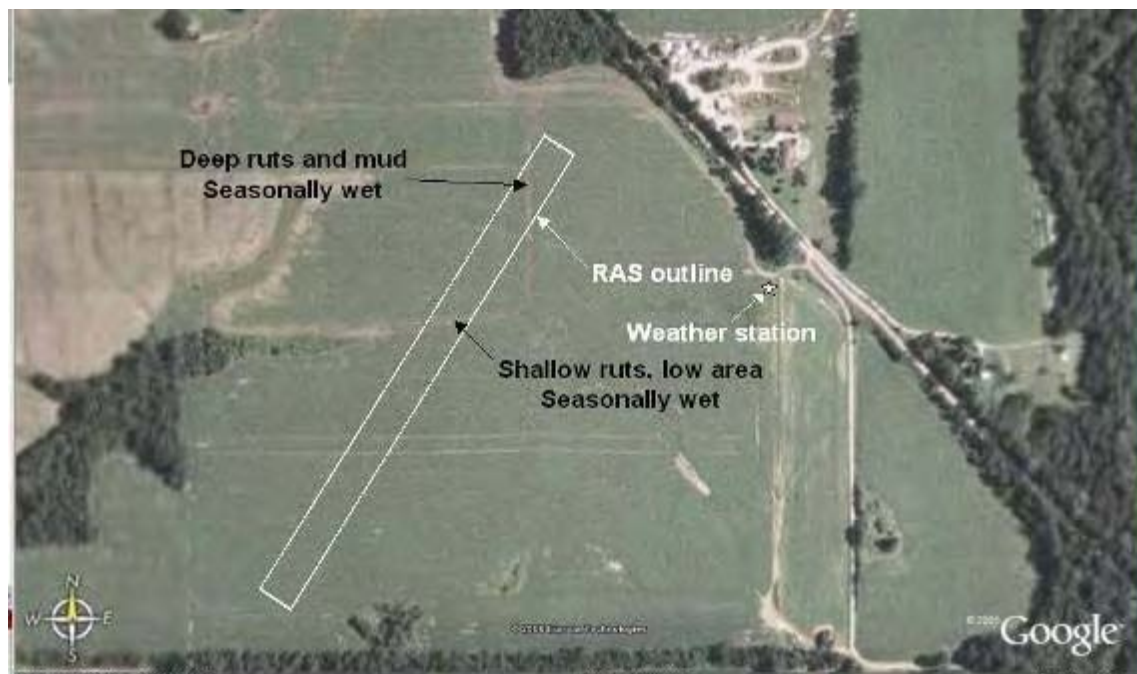
Figure 5-1. Aerial view of the Ford Farm RAS location (outline of RAS is indicated).

Ford Farm RAS is located southeast of Dupont, IN, approximately 30 minutes south of North Vernon off of Highway 7 in Jefferson County. Ford Farm RAS is oriented in a northeast-southwest direction and, similar to the North Vernon Airport RAS, located on a privately owned, actively farmed field. The aerial view in Figure 5-1 (image date unknown) superimposes an outline of the RAS on the field. This illustration shows the approximate location of the RAS in the field, along with some of the natural features of both the field and the surrounding area. Ford Farm RAS is 600-m (1,968-ft) long and 20-m (65-ft) wide. The OLS start point is located at northing 4303798 m, easting 629760 m, and the end point is at northing 4303291 m, easting 629460 m, based on WGS84 UTM Zone S16.

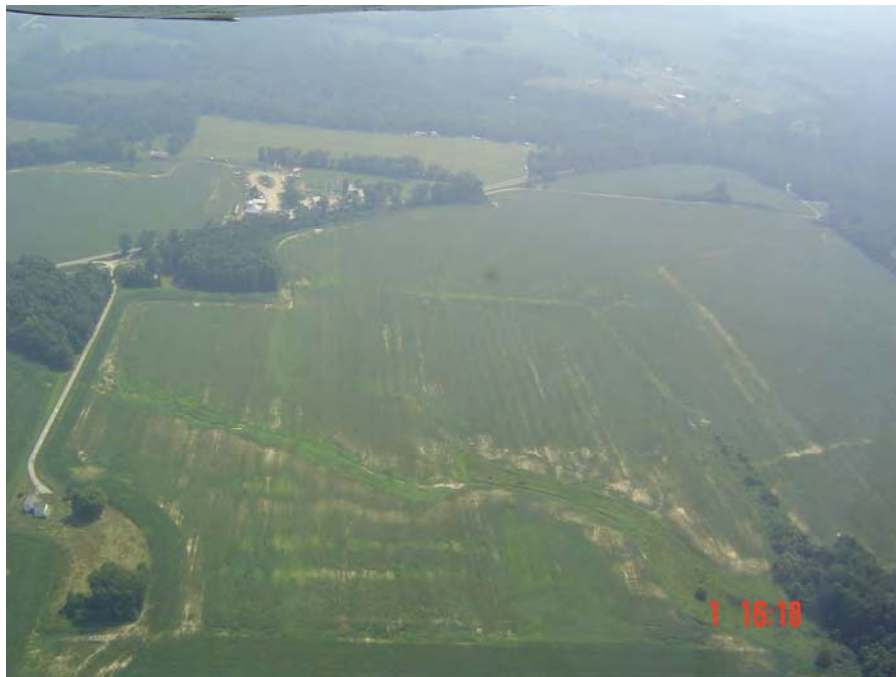
Figure 5-2. Aerial view of the Ford Farm RAS, summer IOP2

To the north-northwest of the RAS is a stand of deciduous trees. A grade with an active railroad, at times obscured by the stands of trees, is located northeast of the RAS with a northwest-southeast orientation. Another stand of deciduous trees borders the RAS to the south. On the west side, at about the RAS midpoint, is a drainage channel that flows from the RAS toward the trees further to the west. As indicated in Figure 5-1, this feature crossed the RAS in two places that are seasonally wet and rutted from farm equipment. Similar conditions were observed in the northeastern area indicated on the aerial image. Figure 5-1 also shows where the weather station was located in relation to the RAS. It was placed on the eastern edge of the field in a grassy, sloped area. This location was out in the open, where the stands of trees did not interfere with the readings, and it was on the same elevation as the RAS. This location also protected the instruments, particularly the subsurface instrumentation, and data collection equipment from the activities in the field. Figure 5-2, taken during summer IOP2, shows a closer aerial view of the OLS and the vegetation coverage.

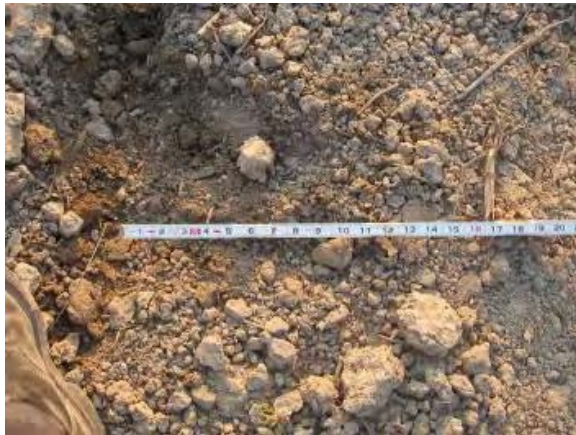
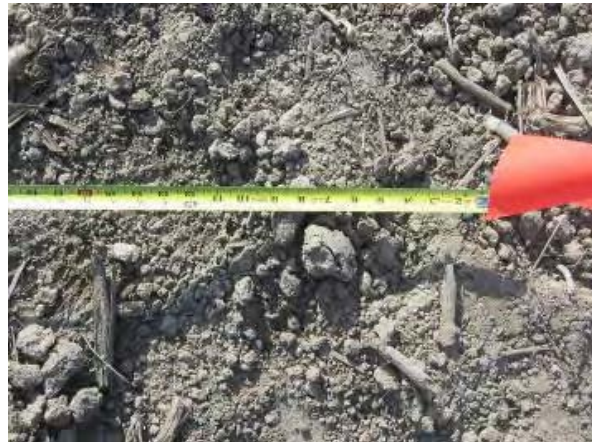
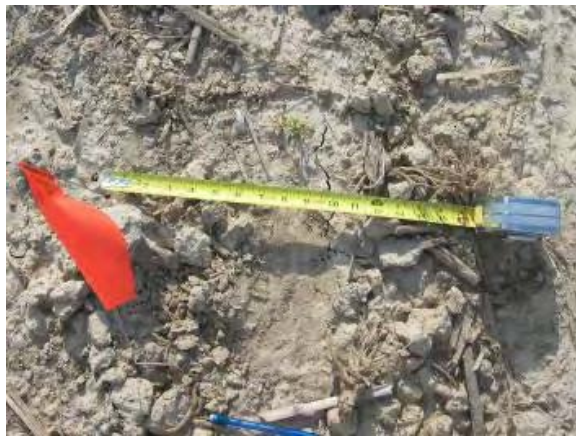
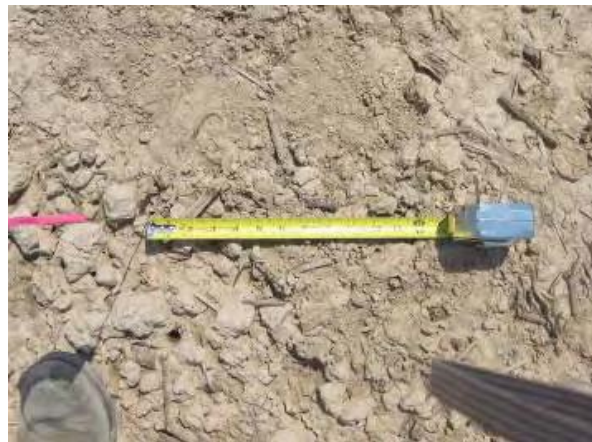
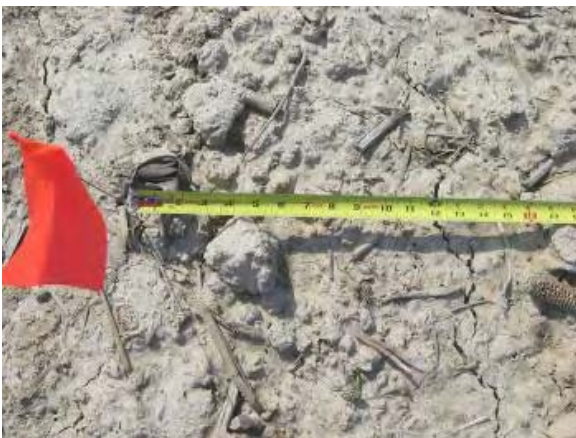
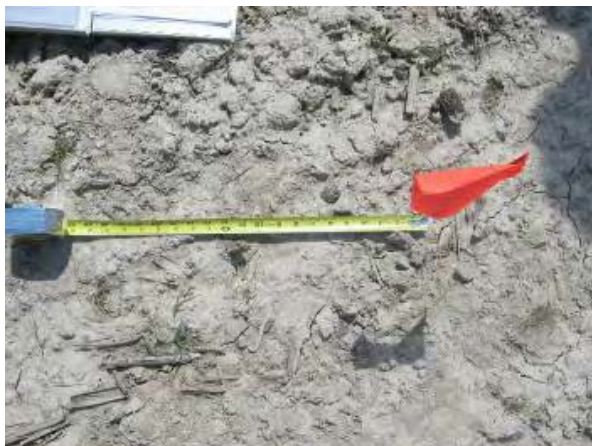
5-4a. 84 m Centerline "wet" (west).

5-4b. 120 m 2 m West.

5-4c. 180 m 2 m East.

5-4d. 300 m Centerline.

5-4e. 420 2 m West.

5-4f. 480 m 2 m East.

Figure 5-4. In situ surface conditions at Ford Farm RAS soil pit locations.

This section describes the soil field measurements collected at the Ford Farm RAS that are anticipated to be unaffected by seasonal change: soil texture, soil color identification, and soil density. Photographs of the in situ surface condition at each soil pit location are shown in Figure 5-4, a–f.

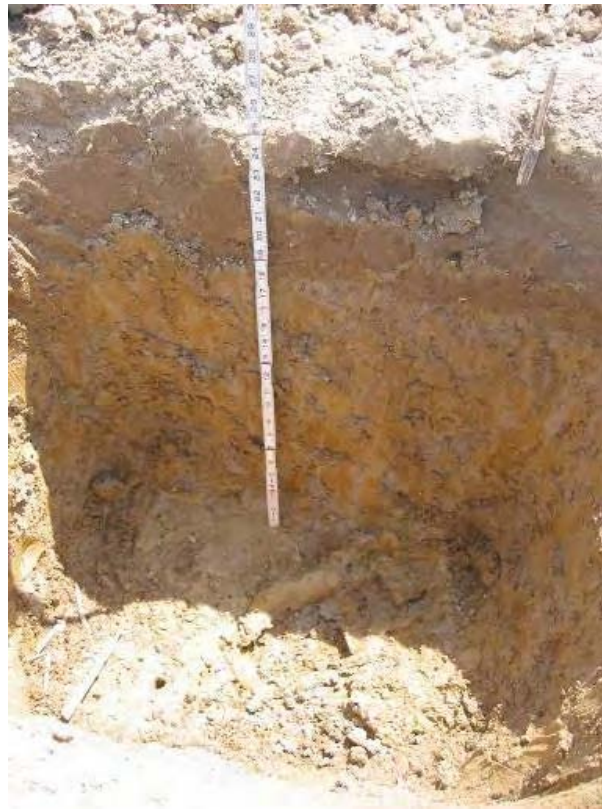
Figure 5-7. Soil pit at Station 300 m Centerline, upper 600 mm of soil pit.

Photographs in Figures 5-7 and 5-8 show examples of the material in the upper 600 mm at the soil pit located at 300 m Centerline and 480 m 2 m East and are representative of the upper layer along the RAS. There is a distinct change in the soil color, most likely associated from the activities from farming (Fig. 5-7). Free water is also visible in the bottom of the pit.

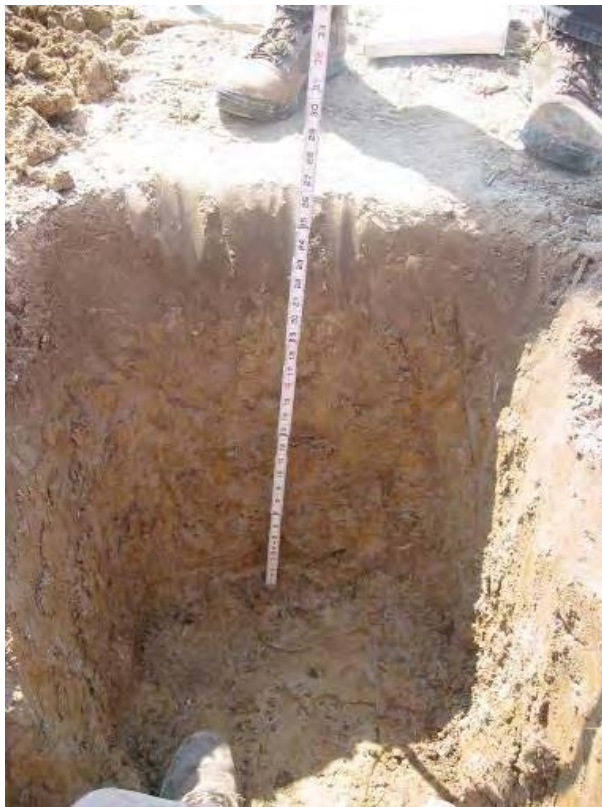
Figure 5-8. Soil pit at Station 480 m 2 m East, upper 600 mm of soil pit.

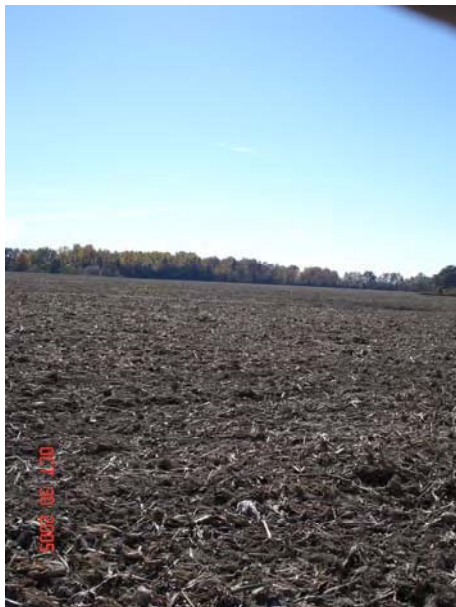
5-10c. Fall.

Figure 5-10. Site conditions of Ford Farm RAS during each IOP: (a) spring IOP1, view looking southwest down centerline from Station 300 m Centerline; (b) summer IOP2, view of weather station showing density of corn field on the left (RAS not pictured); (c) fall IOP3, view down RAS centerline looking southwest from Station 0 m Centerline; (d) winter IOP4, view down RAS centerline looking northeast from Station 600 m Centerline; (e) winter IOP4, cracked soil surface at Station 300 m Centerline.

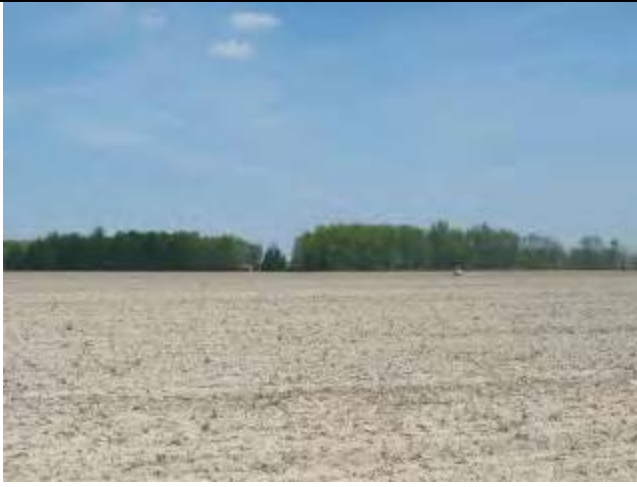
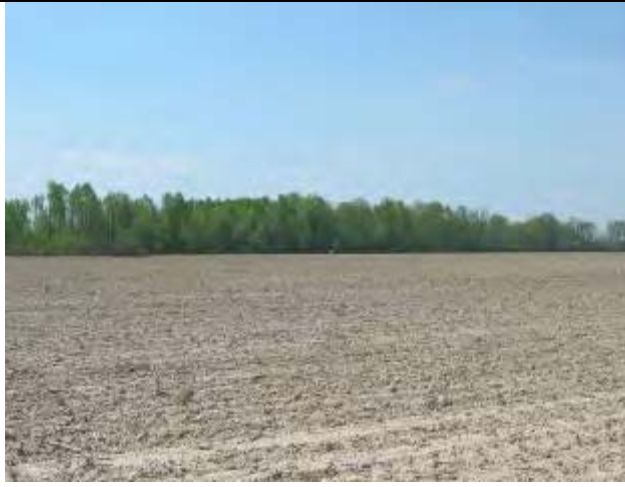
a.	b.
Figure 5-13. Spring IOP1 views down Ford Farm RAS centerline north (a) and south (b) from Station 300 m Centerline.

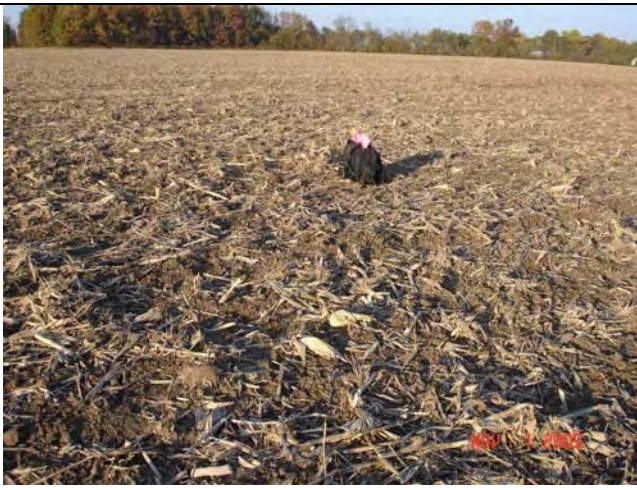
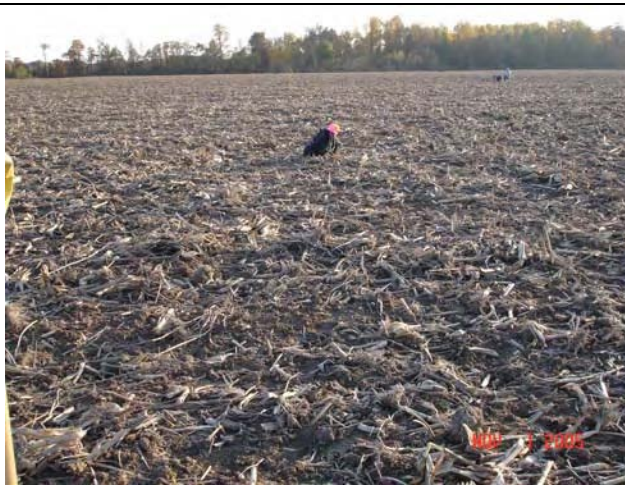
a.	b.
Figure 5-14. Fall IOP3 views down Ford Farm RAS centerline north (a) and south (b) from Station 300 m Centerline.

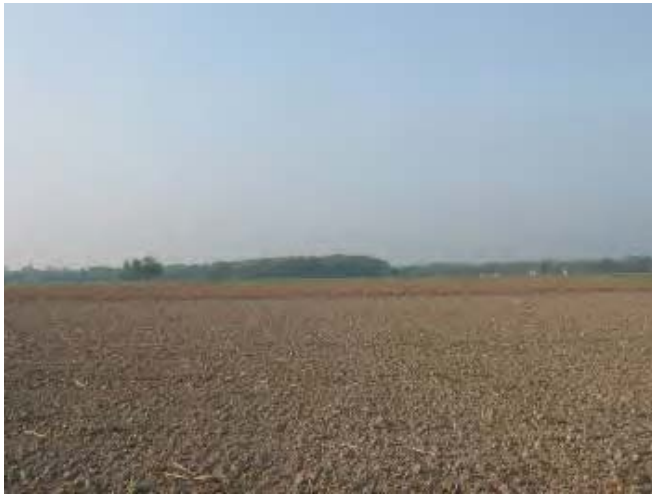
7-2a. Cobbsfork.

The intent of the SAS locations was to evaluate soils that are dissimilar to those at the RAS locations to expand the number of soils characterized beyond the soils at the RAS locations. The common names of the soils at the SAS locations were Cobbsfork, Cincinnati, Parke, and Wilbur (Fig. 7-2, a–d). The SAS locations of soils in Figure 7-2 a, b, and d, were at SEPAC; the Parke soil (Fig. 7-2c) was at MUTC. The photographs in Figure 7-2 were taken during spring IOP1 and show the SAS conditions. Table 7-1 lists all of the measurements collected at the SAS during each IOP.

Figure 7-2. View looking northward of SAS soil test areas (spring IOP1).

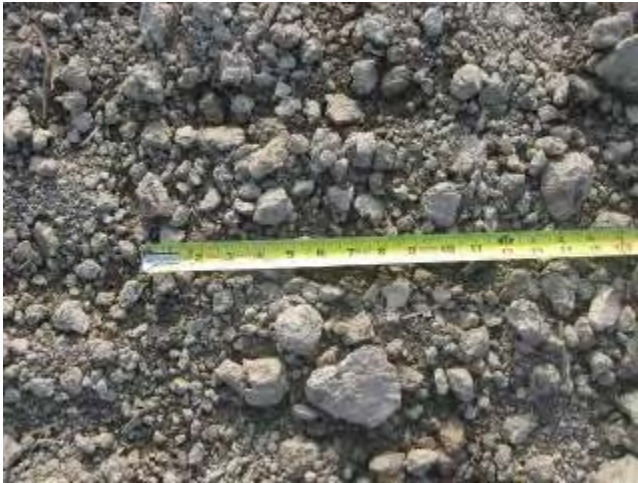
7-3a. Cobbsfork soil.

Photographs of the surface condition during the spring IOP1 at each soil pit location are shown in Figure 7-3, a–d. Grain size analysis plots for each soil type are shown in Figures 7-4–7-7. The plasticity characteristics are plotted in Figure 7-8. Physical soil properties from the soil pit from each SAS are summarized in Table 7-2. In general, the USCS soil classification is a lean clay (CL) with a percentage of fines in excess of 70% at all sites. The Cincinnati soil is a full-depth CL containing some sand; the Cobbsfork material is a full-depth CL; the upper 150 mm of the Parke soil classifies as

Figure 7-3. In situ surface conditions at each of the SAS soil pit locations.
